Khirsara – A Harappan Metropolis in Western Kachchh, Gujarat, India

Received: 19 July 2017; Revised: 26 September 2017; Accepted: 15 November 2017
Heritage: Journal of Multidisciplinary Studies in Archaeology 5 (2017): 541-555

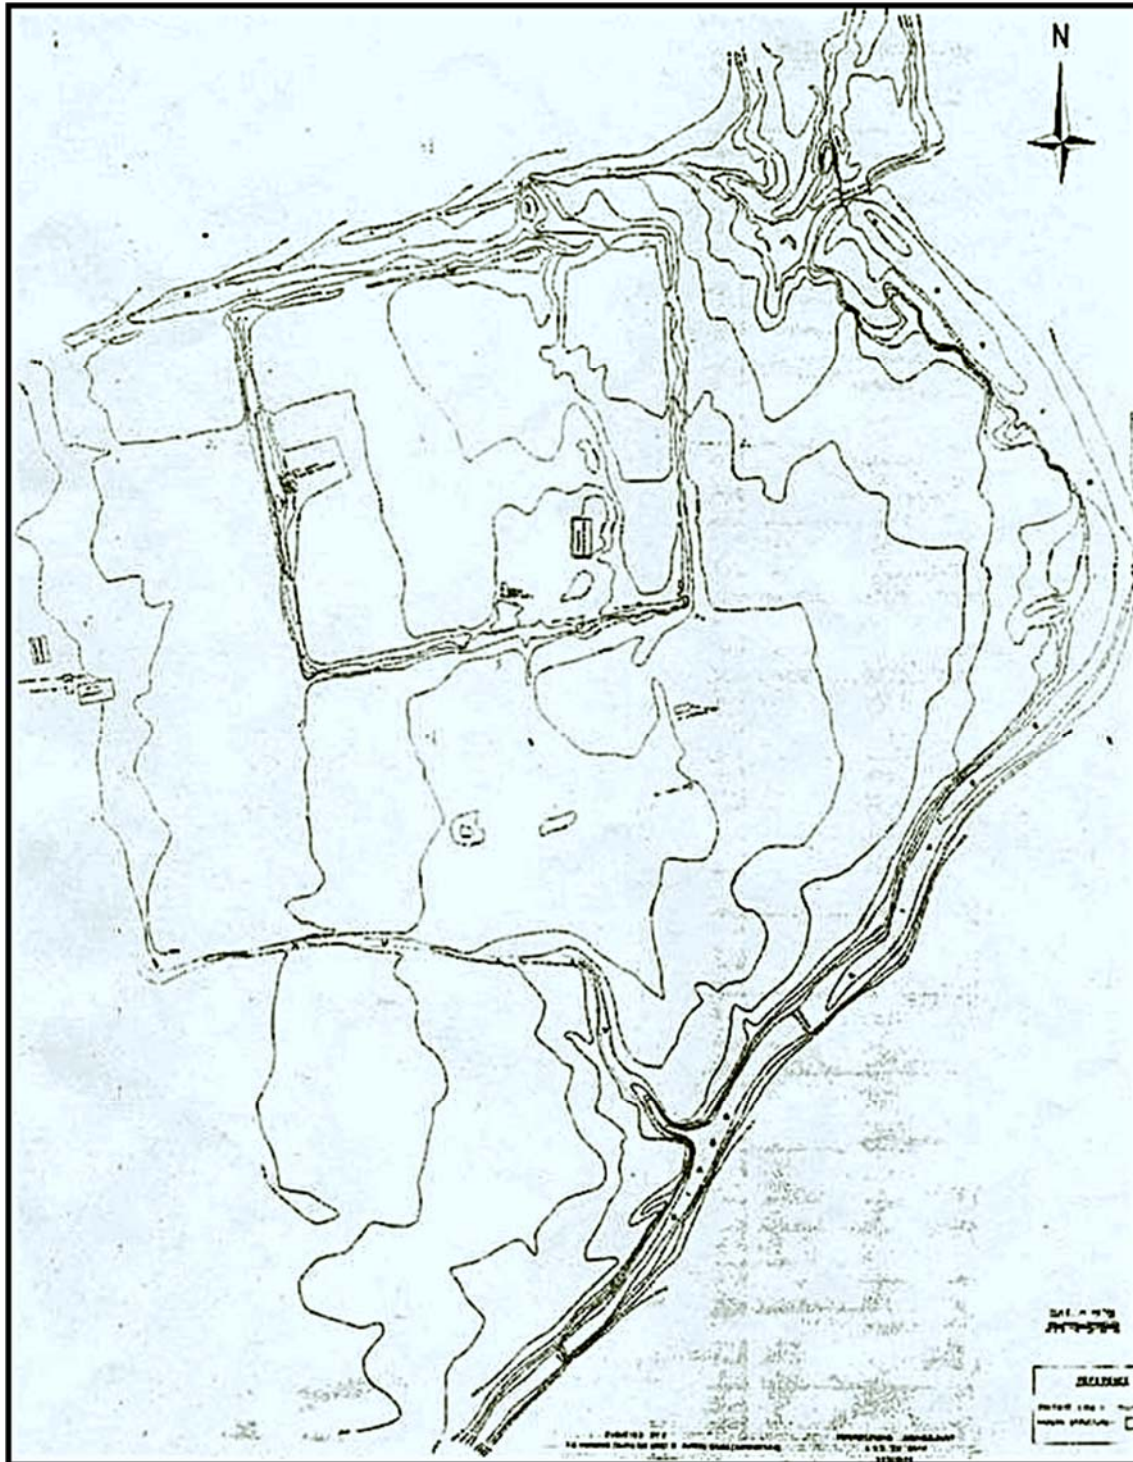
Figure 1: Khirsara, Contour Plan of the Site

Khirsara is a double fortified settlement, roughly trapezoid in shape and the wall was plastered with mud. Measuring 308.26 m on the northern, 278.58 m on the southern, 225.92 m on the eastern and 232.74 m on the western axis, it was provided with

bastions at cardinals and salients at regular intervals. The site encloses the citadel in the south, ware house in the south east, factory area in the centre, residential annexes in the north and series of rock cut kilns on the east. All the units are provided with separate enclosures within a general external fortification, with an exception being the series of kilns – situated beyond the general fortification.

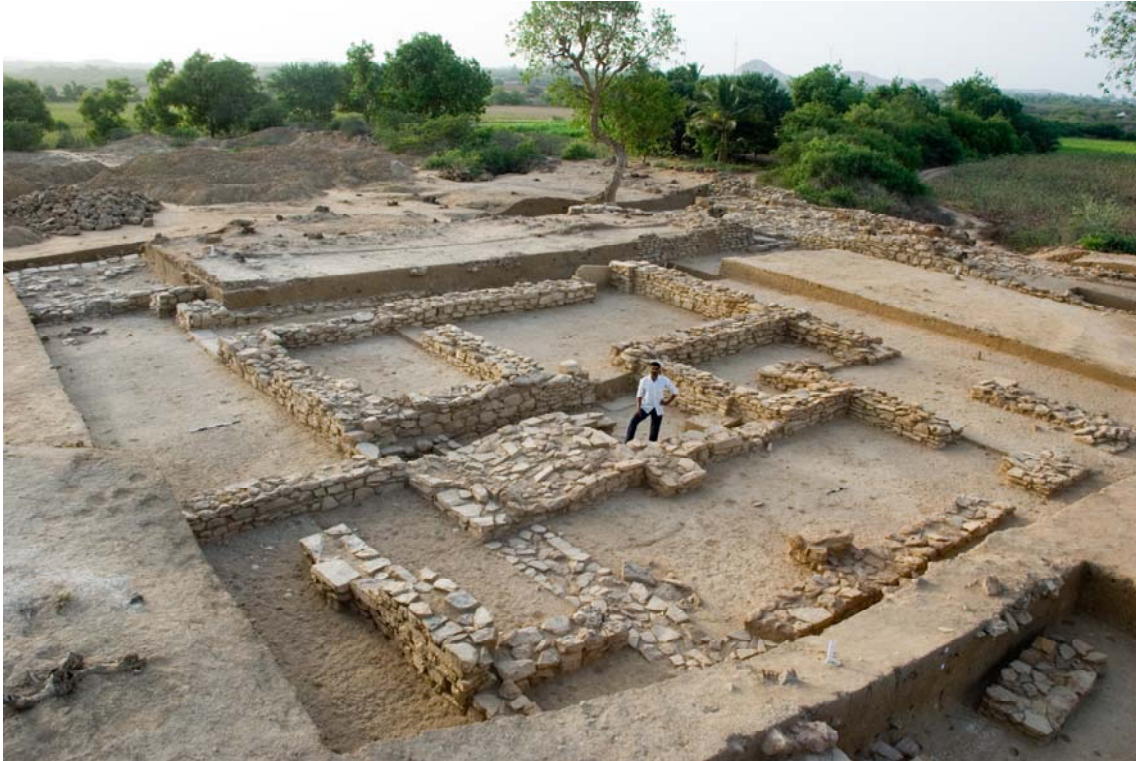
Figure 2: Khirsara, Complex A in the Citadel

Complex A (Figure 2) is situated in the south-eastern side and behind the modern tank. It is just 10.75m from the inner fortification wall of the citadel which runs east-west. This complex that was more or less intact with interconnected rooms, steps, door-sills, offsets, drains, hearth, post holes and entrances. The main entrance of this complex is on the east which opens into a passage with 2m width. This passage was provided with fine dressed doorsill of sand stone in the north. Post holes are noticed in almost all the rooms which indicate that the super structure might be of perishable materials.

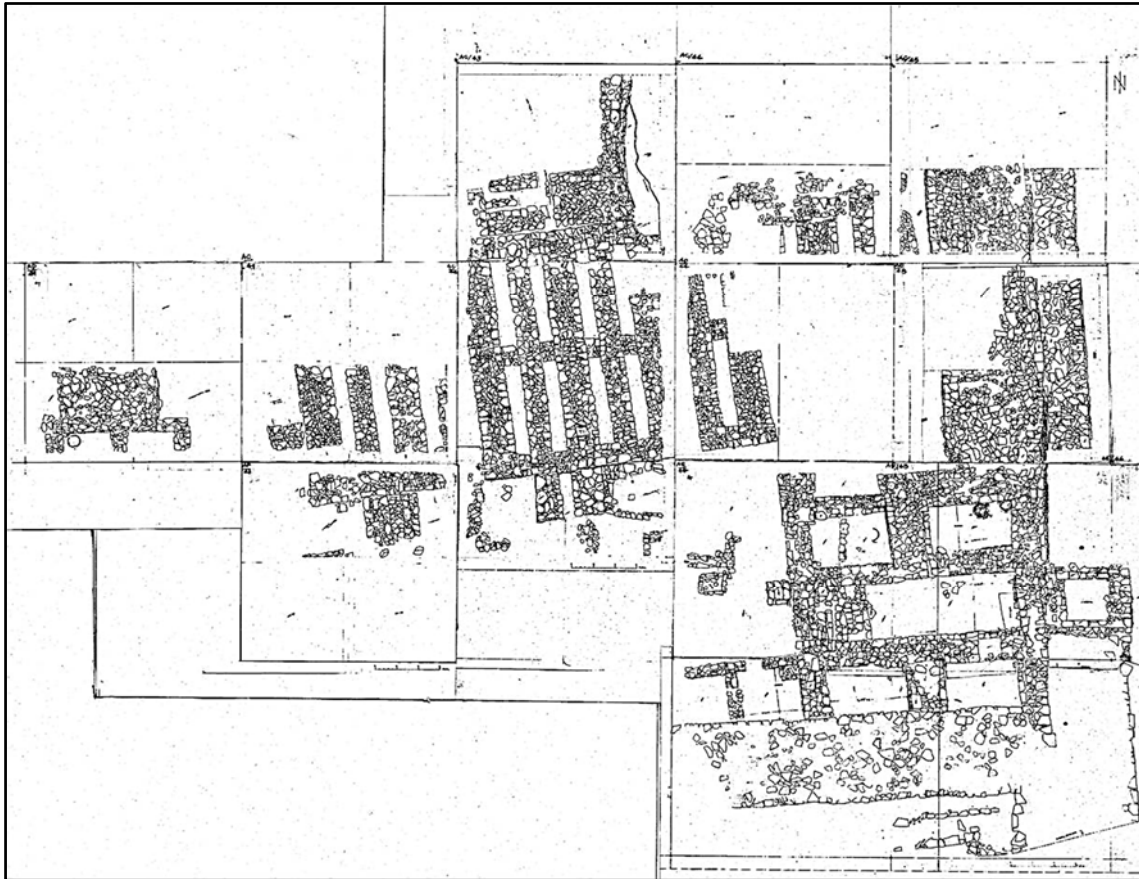
Figure 3: Khirsara, General View of Ware-house Area

The excavations (Nath et al., 2015: 205 – 212) carried out in the south-eastern portion revealed the evidence of a 'ware house' (Figure 3). This structure, 'square built to courses' masonry of sandstone with mud as binding medium and was most probably plastered. Situated east of citadel, it measures 12m (north-south) x 28m (east-west) and consists of a series of 14 parallel walls laid in north-south orientation with an average length of 10.8m. The width of these walls varies alternatively from 1 to 1.55m and was bisected by three walls running east-west at regular intervals. Further, after the end of the complex, an extension of the same was noticed on the southern side. The areas in between the parallel walls were rammed with ceramics and bones.

A working platform of 2.20 m x 3.50 m was provided on the northern side of the ware house. The super structure of the ware house seems to have been made of perishable item like wood or wattle and daub. The space in between the parallel walls might have served as air duct for circulation of fresh air to protect the stored materials. The structure was purposefully raised in this part adjacent to citadel and close to the south-eastern entrance with a flight of steps and series of guard rooms. Its close proximity with river Khari might certainly have supported the riverine trading activities of the Khirsarans.

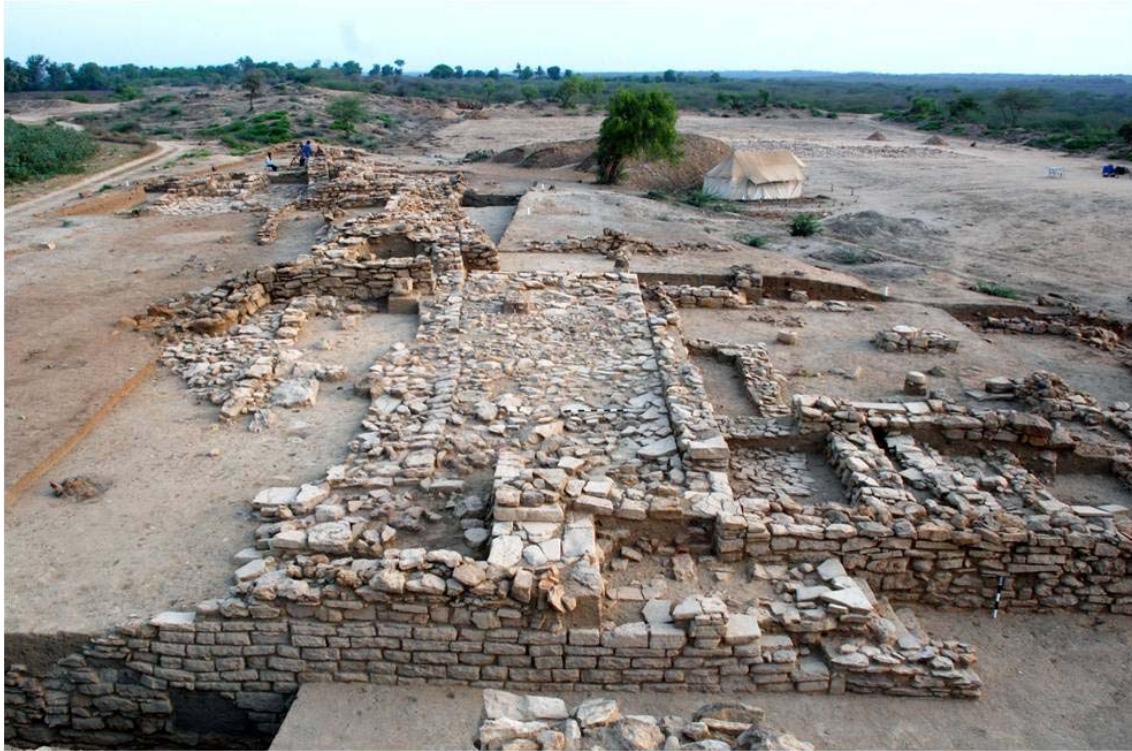
Figure 4: Khirsara, Factory Area

The factory area was located just opposite to the northern fortification wall of the citadel with a 5m pathway in-between them (Figure 4). It covers an area of around 6, 600 sq. m. which was half of the citadel area. The excavations here has revealed well planned complexes with spacious interconnected rooms, multifarious entrances, stone paved and plastered flooring, pillar bases, drains, water tank, series of storage jars, flight of steps, kilns, hearths, etc. The layout of the factory area in the early stages of the settlement at Khirsara is doubtful. However, early phase structures in the form of rooms with entrances of 0.80m, stone paved flooring and hearths were noticed in the index trenches. The structures are raised with sandstone of good quality in random

rubble course masonry with mud mortar. As these structures are extending into the unexcavated area, its actual plan could not be ascertained.

In the next phase, the whole site was reorganized. The factory area was redrawn or it was newly planned over the early phase structures. During this phase, a separate fortification of 3.50m was raised around the factory area with the main entrance on the north. The natural contour of the site was well tailored by the Harappans in raising these structures. Well dressed stones of similar sizes were used at the entrance while huge fair face sandstones were employed on the outer wall particularly at the base. This entrance was maintained throughout the occupation of the site though on a reduced scale during the later phases. With a guard room towards the east, the street was 4.70m in width running towards south. Another entrance with a flight of five steps was provided on the southern wall to access from the citadel pathway. The width and the height of the steps are equal in proportions. Meticulously executed third entrance was noticed between the complex 2 and 3 in geometric pattern. The cardinals of the factory were raised with angular stones and this makes the wall to be inclined. Throughout the second and third phase, the rooms are larger in size and polished sandstones are utilized. During the fourth phase, the sudden spurt of activities was noticed in the form of extension of the factory area beyond the fortification on the east, west and north-eastern side. Though the stones betray the early phase, the alignment was almost maintained. The entrance on the north was narrowed. Flat stones of various sizes were laid at the entrances to use as pathways. The eastern one was closed by raising a wall parallel to it while the southern was rebuilt. The guard room was

shifted outside and bifurcated. These rooms are semi circular in plan. The intense industrial activity was noticed in the form of hearths, charcoal, ash dump and discarded pottery scattered all over the area. The rooms are partition according to the necessity. The pillar-bases and post-holes in some of the rooms and even on the fortification wall in the form of embedded cylindrical pots show that the super structures might be of thatched roofs or of perishable materials. The floors are both laid with flat rubble stones and plastered with mud brick materials or rammed shell debitage or mud. One of the complexes was provided with flight of steps. Nearly six complexes and same number of platform along with furnace and hearths were identified and each has a specific role in the production of shell, bone, semi-precious stone beads, steatite micro beads, copper objects, etc.

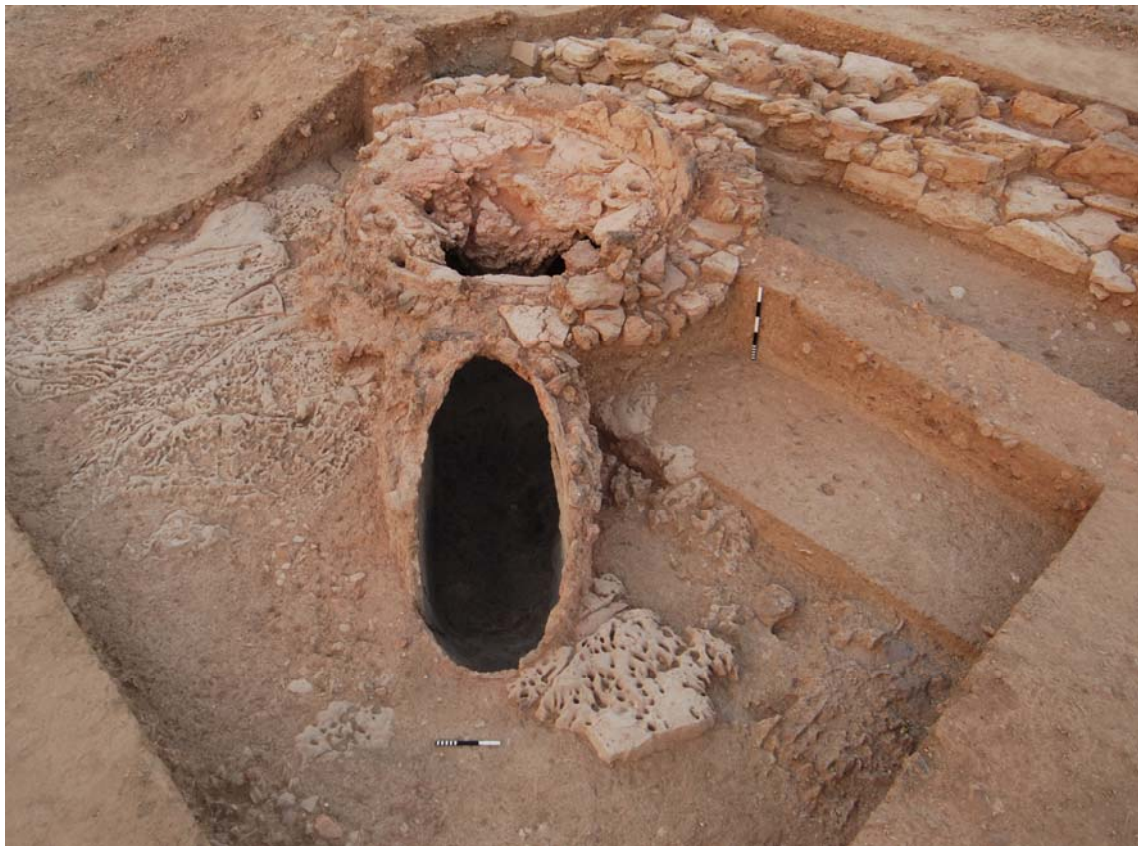
Figure 5: Khirsara, Kiln

A series of kilns of various sizes were identified during the exploration along the eastern side of the outer fortification wall. These kilns are secured by 2.60m wide second fortification wall. Of them two were exposed. The first one is circular on plan and has two chambers, one above the other (Figure 5). Its longer axis along the mouth meant for supply of fuel had two hollow compartments. The fire reaches the upper chamber through 15 flues, all of which are interconnected. The walls on both the sides are mud plastered. Due to constant firing at high temperatures, the walls are vitrified. Except stray potsherds and ashes nothing was recovered from their inner chamber. It clearly indicates that most probably the objects were kept one above another on the top for baking. The evidences also shows that in the later stages, the use of the kiln was minimized in the form of raised inner wall in-between the longer axis and circular chamber and also in the form of few closed flues with flat stones on the outer surface. This kiln measures 3.8m in diameter and 5.42m in longer axis. The diameter of the flues ranges from 0.10m to 0.15m. The second kiln is also rock-cut one and circular in shape. With a fuel chamber in front – all are open. The interior of this kiln also shows the evidences of firing at a high temperature. The diameter of the chamber is 2.20m and the overall length is 3.60m (Nath et.al., 2015: 272 – 282).

The reason for constructing the kilns outside the main fortification wall shows the safety measures adopted by the Harappans in preventing fire hazards and secondly, the easy availability of raw materials from the nearby area. As the river is situated just near the site and the ground area is flat natural rock which is ideal to keep ceramics to dry when in leather hard condition.
