Disappearing Heritage: A Case Study from Belagavi, Karnataka

Abstract: Rapid urbanisation is becoming one of the major threats to archaeological monuments and sites. Also, there are elements of human vandalism showing up in many regions. These have destroyed a large number of cultural remains from the land. This paper assesses the present-day state of preservation of a set of monuments in Belagavi. The megalithic monuments in this region were documented by earlier workers. The present work notes that unless some urgent measures are taken by government authorities, these monuments may even fade from memory soon.

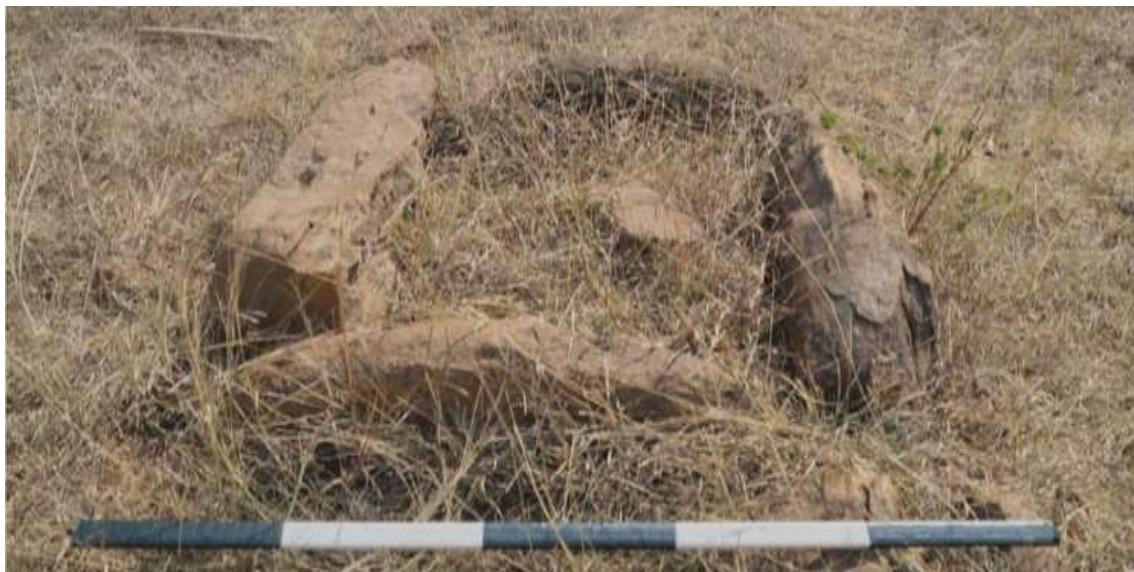
Figure 5: Small Square Chamber at Hidkal

Small Square Chambers: A very rare type of chamber tomb is built of five stone slabs: four orthostats in the cardinal direction and the fifth on top; the capstone. These variants are small in size, measuring about 50cm (average) on each side (Figure 5). Tombs such as these are seen around passage chamber dolmens, probably part of a complex. These chambers have no passage but are covered with cairns.

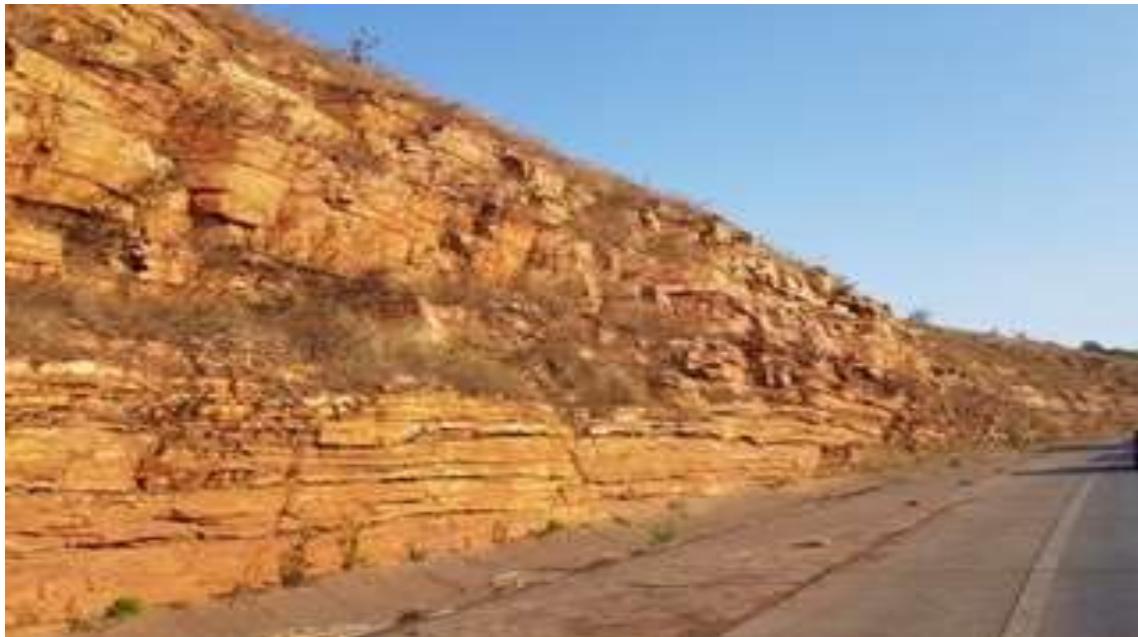
Figure 6: Sandstone source, Kaladgi Hills. Well exposed due to road construction

The chamber tombs were built of locally available sandstone slabs from the nearby exposure (Figure 6). The cairn packing consists of quartzite sandstone rubbles, Deccan trap pebbles, and sometimes river-worn quartz pebbles in odd proportions (Sundara 1975). Pegmatite is also found in the cairn mix; however, it is only connected with Passage Chamber Dolmens. Pegmatite and white quartz are not readily available in the surrounding area; this could be a significant indicator of a death rite. Sandstone, Deccan trap pebbles, pegmatite, conglomerate, and laterite were the five stones chosen. Orthostats show no signs of dressing or straightening of edges, probably due to the availability of naturally split stone slabs of convenient shape and size. Rough dressing was recorded on the rectangular slabs that enclosed the cairn packing and the chamber tombs. Some well-dressed conglomerate slabs were found in the cairn packing of a long barrow (Figure 7).

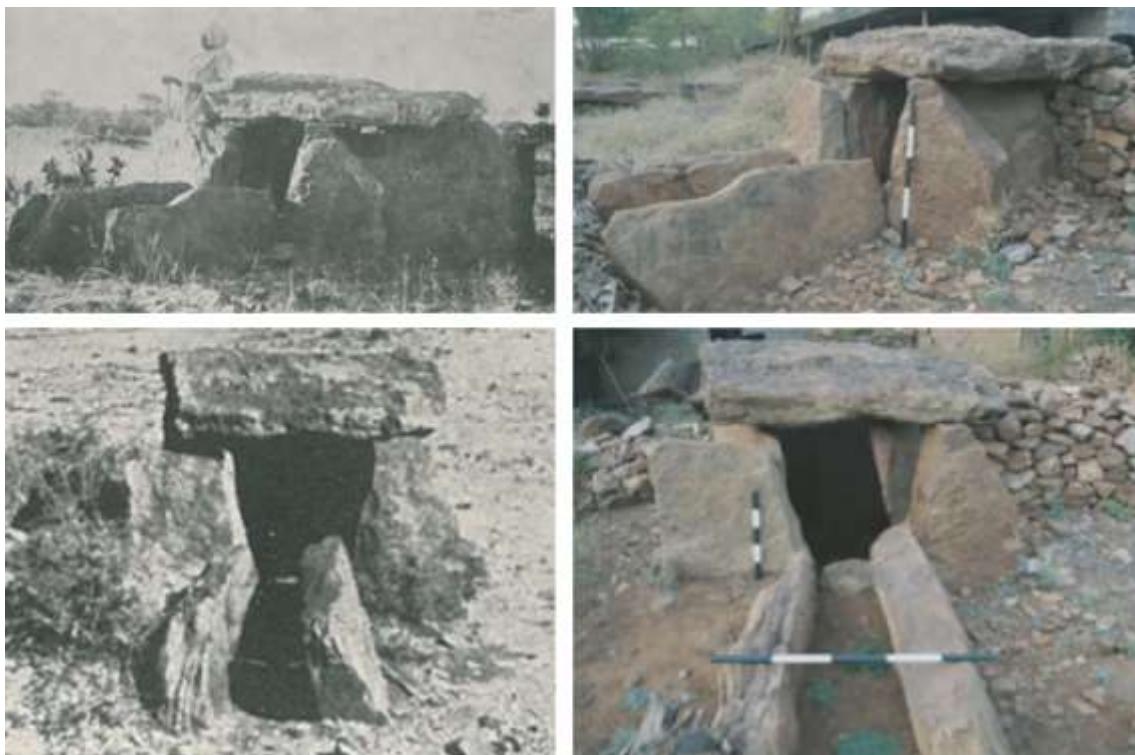
Figure 8: Passage chamber dolmens photographed from 1975 (Sundara, 1975) in comparison with 2018

The following tables will give a detail record of 1975 (Table 1) in comparison with the record of 2018 (Table 2) (Figure 8).

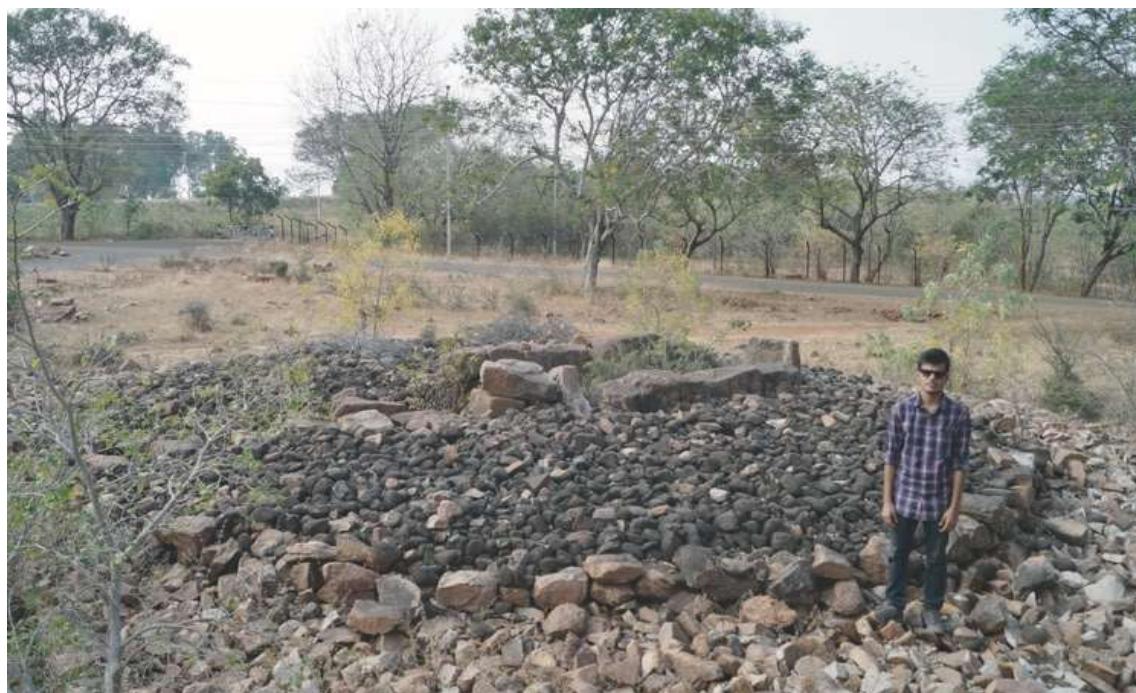
Figure 9: Reconstructed Long Barrow at Hidkal Inspection Bungalow

Honnur (in Previous Records: Hunur): Honnur was excavated as a salvage operation by S.R. Rao in 1969 and 1970 by the Archaeological Survey of India, south-western circle, Aurangabad, Maharashtra (IAR, 1968–69). The chamber tombs were relocated to the inspection bungalow at Hidkal (Figure 9). The sites at Honnur have submerged underwater due to the dam construction.

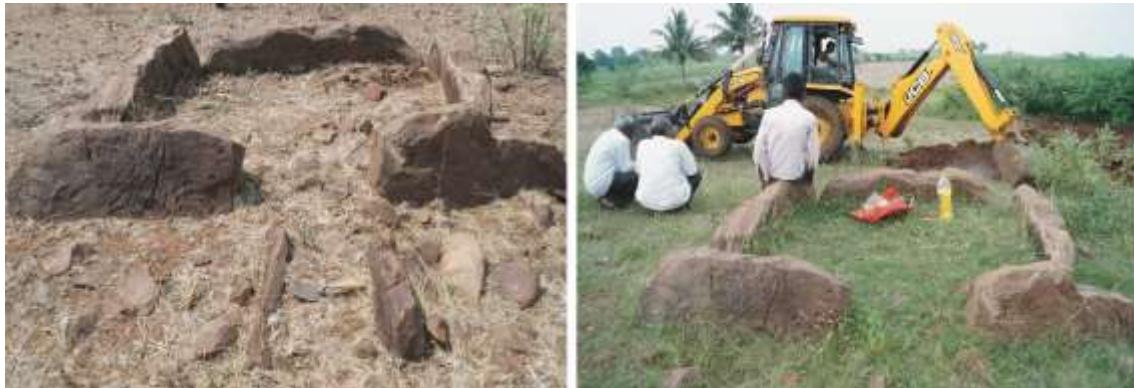
Figure 10: Destruction of the site at Pachhapur - June, 2017 (Left) and September, 2018 (Right)

The sites in this region are mainly disappearing due to the ever-expanding farmlands. Local agriculturalists use earth-moving machines to raze these megalithic monuments, as seen at the site of Pachhapur (Figure 10). An attempt was made by the first author of the paper to make the local agriculturalists aware of the significance of the site, where the monuments were left undisturbed. An exception was seen at Savalagi, where an approximate total of 50 such monuments were razed to make a cemetery right on the edge of the village. Another cause of the disappearance of these monuments is the building of a dam on the river Chataprabha. The reservoir of the dam has submerged the sites at Honnur and Jinalar. On the other hand, megalithic monuments are also a good and easy source of stone slabs, the raw material for building houses in the rural settings of north Karnataka. These slabs are either used in building houses or taken to

the stone crushing quarries. The rise in the construction of *pukka* houses in rural India is one of the major contributors to the destruction of these monuments. The mounds are flattened, and the monuments are continuously removed to either extend the agricultural lands or build infrastructure such as houses or irrigation tanks for farming.

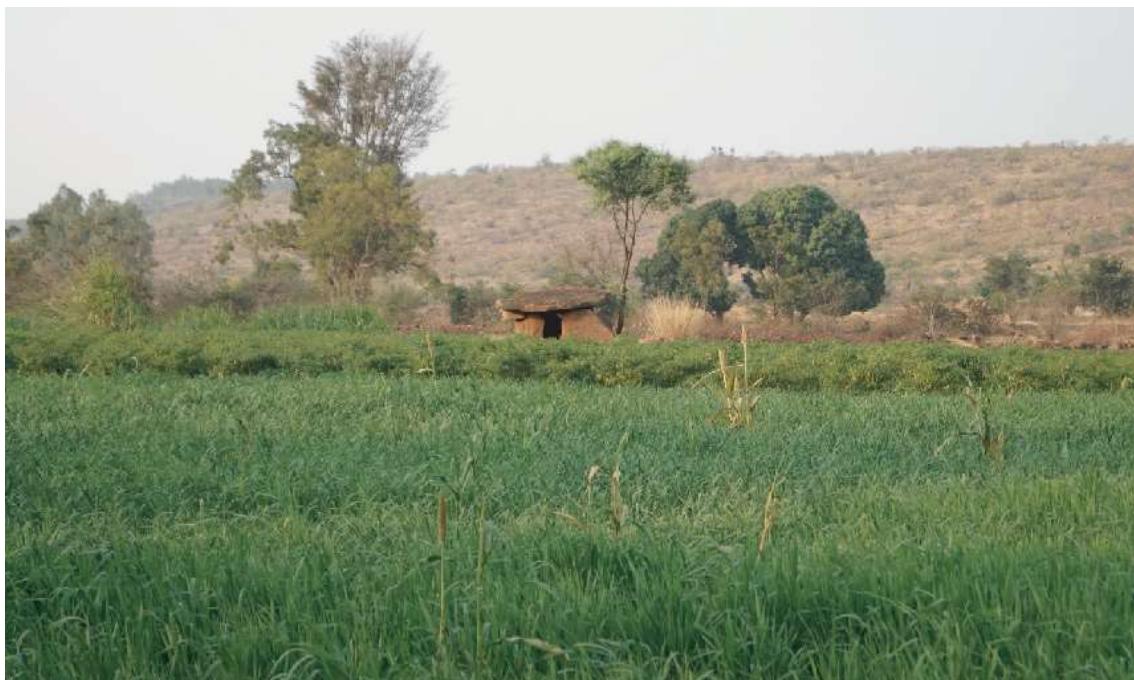
Figure 11: Isolated Megalithic monument at Godchinmalki

The site at Konnur is protected by the Archaeological Survey of India, Dharwad Circle, Karnataka (Figure 12c). Only a part of the site at Konnur is under protection; the vast majority of it is destroyed. Although four such Megalithic monuments are protected by the local Jain community, they believe that monks used to meditate inside them (Figure 12d). Farming has taken over this region, and many monuments have been removed, yet remnants of this grave architecture are seen in the farms of Konnur and

Godchinmalki (Figure 11). Chamber tombs converted into temples are another important factor, as seen at Savalagi, where a local deity called *Kari Kallavva* sits inside (Figure 12a). These Megalithic monuments are used as storage by the farmers to keep their tools and apparatus needed for farming stored inside them (Figure 12b).
