Stucco as a Building Material - A Study of Its Composition, Use and Scientific Analysis

Heritage: Journal of Multidisciplinary Studies in Archaeology 8.2 (2020): 662-679

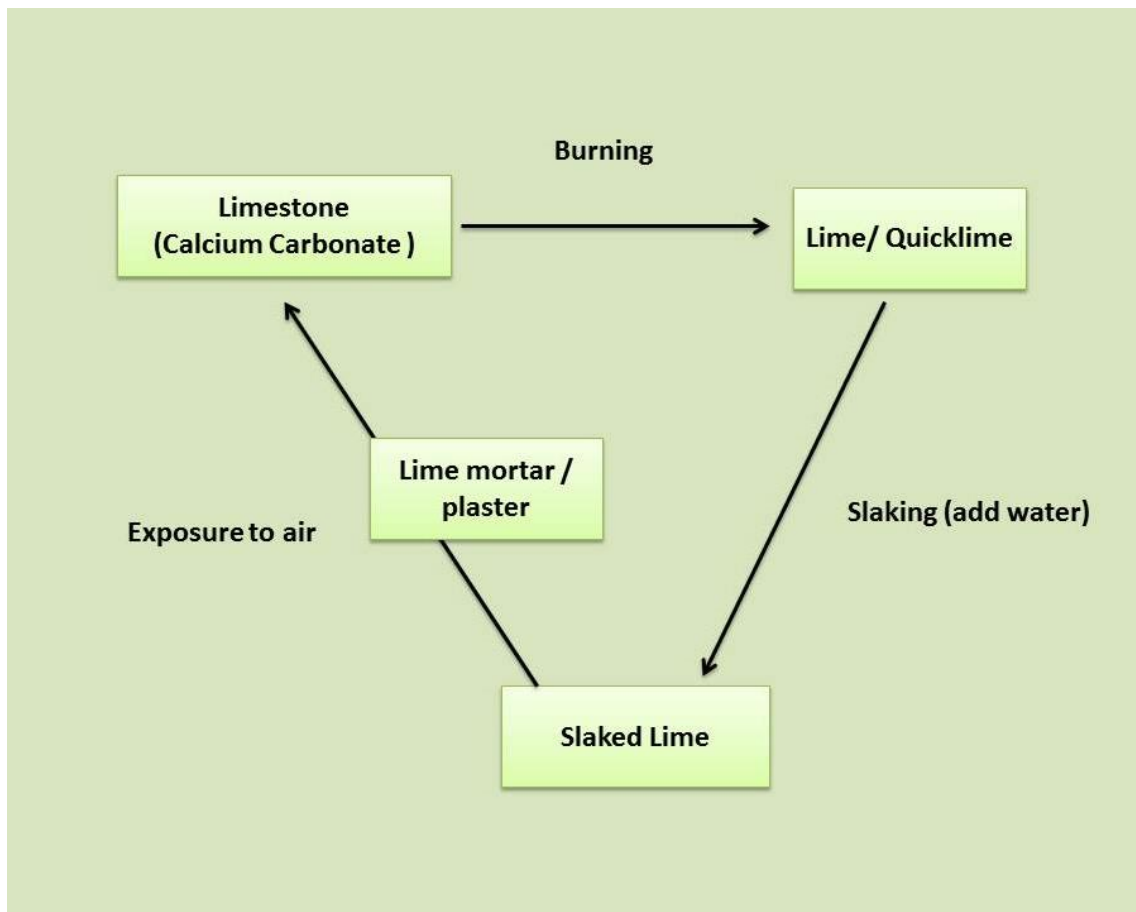
Figure 2: Preparation of slaked lime

Hydration: Calcium Oxide (CaO) + Water (H_2O) = Calcium Hydroxide $\text{Ca}(\text{OH})_2$ i.e., Slaked or Hydrated Lime (Figure 2) + Heat

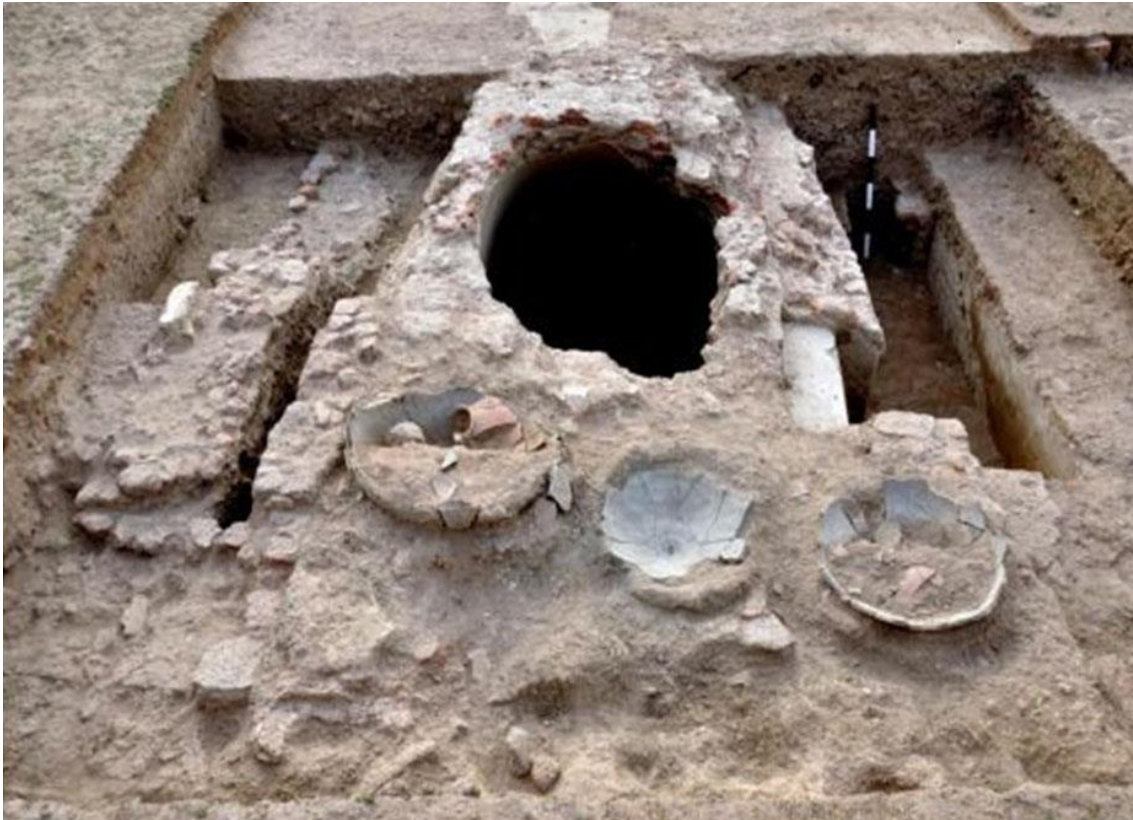
Figure 3: Tank with lime coating, Bharuch

Another interesting evidence of using lime (stucco) as plaster coating has come from the site of Bharuch, in Gujrat (Figure 3). Trial excavations have been undertaken at Bharuch, by the excavation branch-v, Vadodara, in 2013-14 of the Survey. In the Soneri Mahal area, excavation has revealed an oval shaped water structure or a tank which was built with burnt bricks with lime mortar and coating (IAR 2013-14).

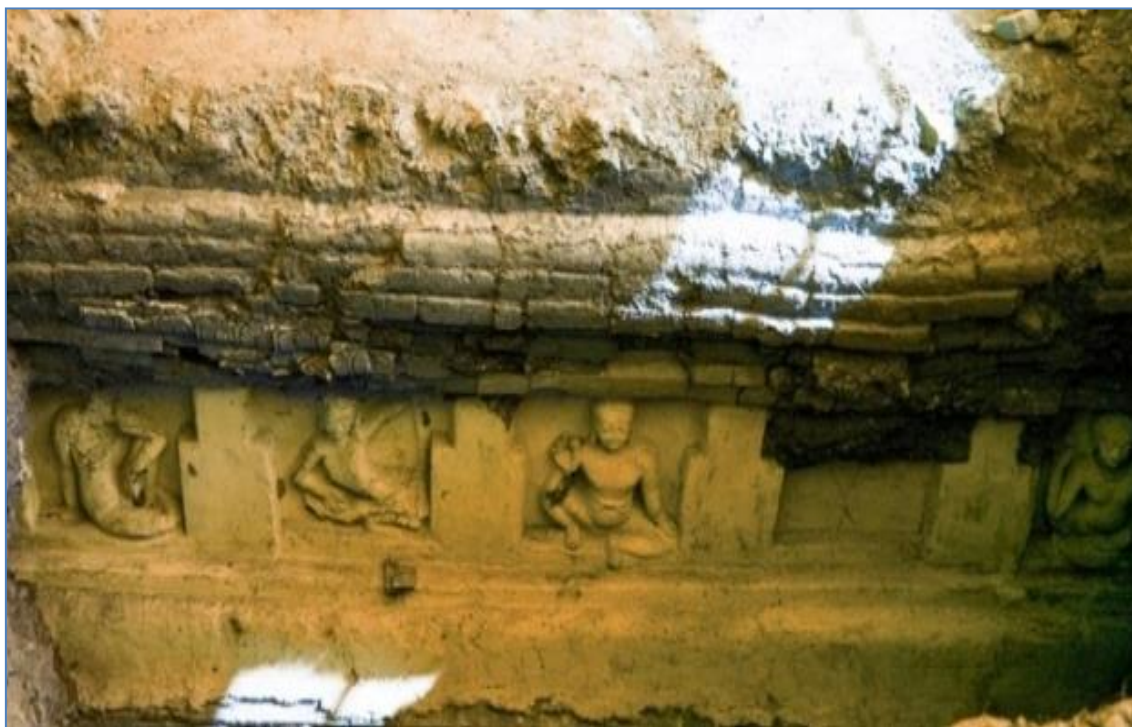
Figure 7: Stucco panel at Moghalmari

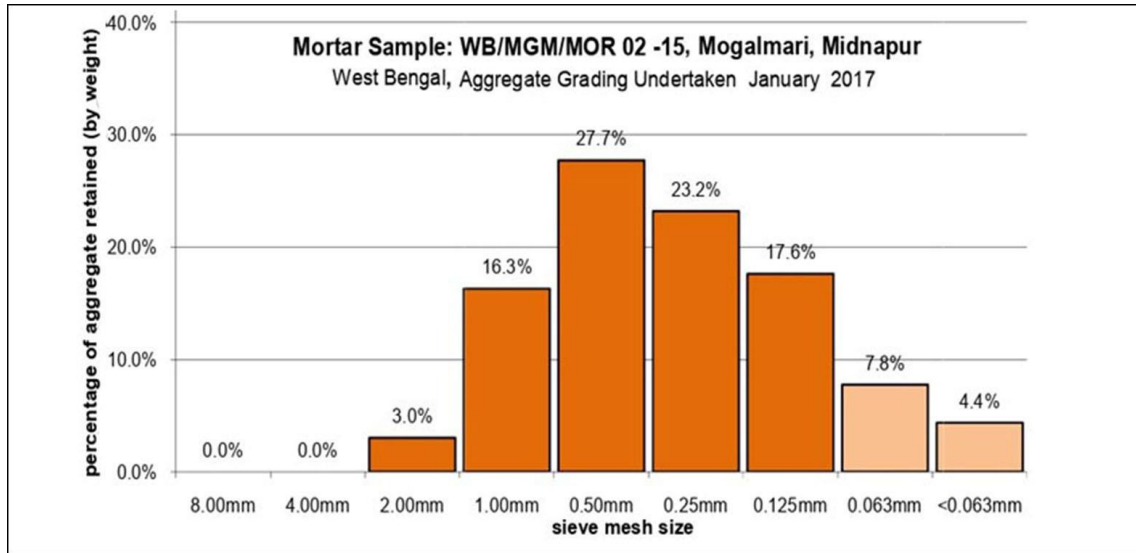
Figure 10: Aggregate Grading of Mortar Sample

Aggregate Grading			
Sieve Number	Aggregate weight retained (g)	Remarks (under microscope)	Photograph (Under Microscope)
2mm	1.06	Angular lime patinated aggregates probably brick bats. <i>Colour: 5 YR 7/4 Pink.</i>

1mm	5.70	Angular lime patinated aggregates probably brick bats with traces of carbon. <i>Colour: 5 YR 7/3 Pink.</i>

500 micron	9.69	Angular small brick bats in various shapes. Lime patination were seen. Carbon particles were increasing. <i>Colour: 7.5 YR 7/3 Pink.</i>

250 micron	8.10	Angular tiny pieces of brick bats. Presence of carbon. <i>Colour: 7.5 YR 6/4 light reddish brown.</i>

125 micron	6.16	Powder may be <i>clay or surki</i> . <i>Colour: 5 YR 5/6 light brown.</i>

63 micron	2.71	Fine dust may be <i>clay</i> . <i>Colour: 7.5 YR 6/4 light brown.</i>	 
Less than 63 micron	1.53	Very fine dust may be <i>clay or surki</i> . <i>Colour: 7.5 YR 6/4 light brown.</i>

be fully carbonated. On fracturing, it was found to be moderate and friable. The sample was again examined under a microscope at 25 Magnification. The aggregates mostly had angular brick bats in various shapes. Traces of lime patination and carbon particles were noticed. This sample on dissolving in 10% Hydrochloric acid resulted in a strong reaction which lasted for half an hour. After analyzing the sample, it was found that the type of lime in this mortar was hydraulic lime binder. In this stucco composition we find the presence of brick bats, carbon, clay or *surki* powder and fine clay dust. The Hydraulic lime has been recognized as the binder.

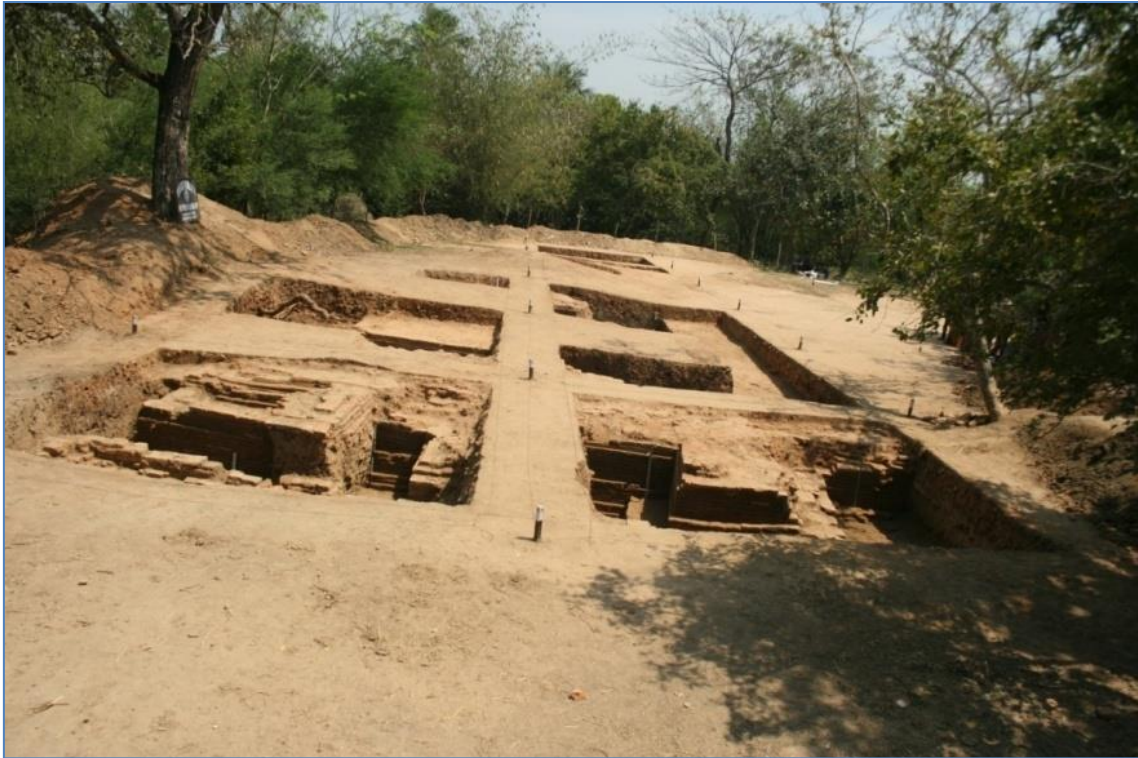
Figure 13: Excavated Trenches at Kankandighi

Kankandighi is located in the District of South 24 Parganas under the Jurisdiction of Raidighi Police station, on the bank of river Mani (Figure 13). On the basis of cultural materials and structural remains with moulded bricks, it has been suggested by the excavator that the whole structural complex flourished during tenth/ eleventh century. The structural remains unearthed during this excavation belonged to a Buddhist monastic complex (Basu, 2017). As a regular practice in early medieval monasteries in eastern India, the Kankandighi Buddhist monastery also marked with the use of stucco compound for the construction works. Unlike Moghalmari, its use was restricted to the building activities only. Stucco was found applied for plastering and cementing the bricks (Figure 14). The stucco sample has been collected and analyzed by laboratory testing which gives us some very interesting information about its composition and ingredients (Figures 15-17).

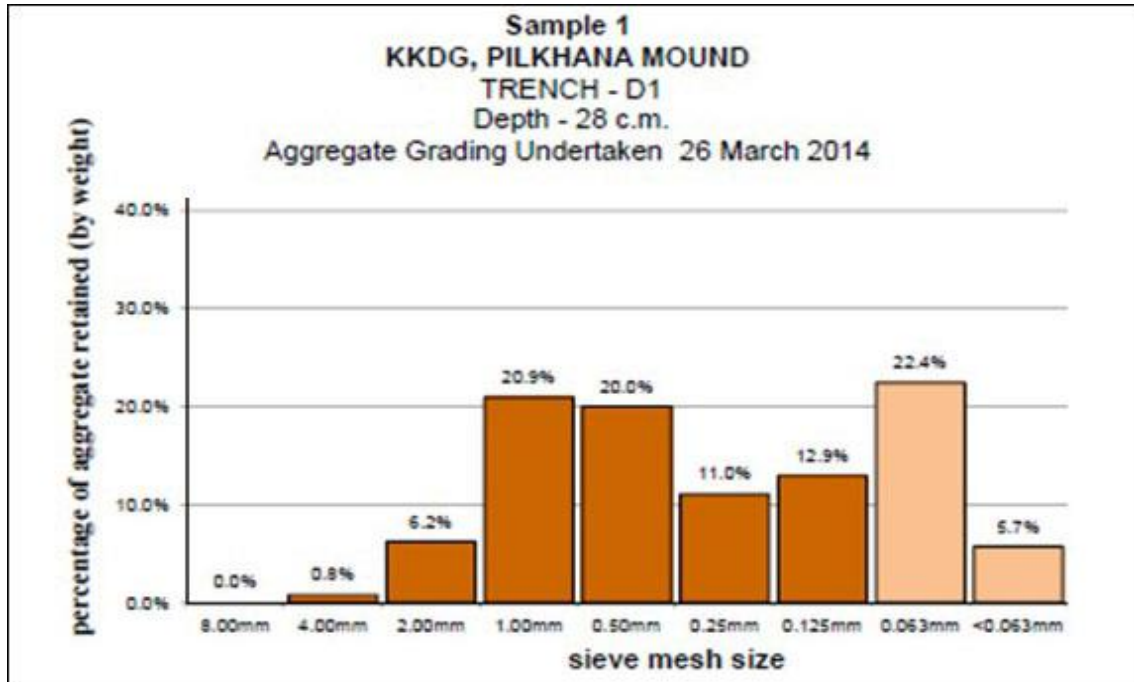
Figure 17: Aggregate Grading of Mortar Sample

Aggregate Grading			
Sieve Number	Aggregate weight retained (g)	Remarks (under microscope)	Photograph (Under Microscope)
8mm	0		
4mm	0.31	Angular rock particles of lime stone mainly dolomite. Presence of low graded marble

2mm	2.5	Angular rock particles of lime stone mainly dolomite. Presence of low graded marble with small quantity of charcoal, and brick bats, quantity increasing

1mm	8.41	Angular rock particles of lime stone mainly dolomite. Presence of low graded marble with small quantity of charcoal, and brick bats, % of brick bats increasing

500	8.05	Angular rock particles of lime stone mainly dolomite. Presence of low graded marble with small quantity of charcoal, and brick bats, quantity is less than previous

250	4.44	Angular rock particles of lime stone mainly dolomite. Presence of low graded marble with small quantity of charcoal, and brick bats, quantity decreasing

125	5.19	Dusty material, quantity increasing

63	9.02	More fine dust

Less than 63	2.29	Very fine dust

Kankandighi sample has provided us some very interesting information. The laboratory analysis has been done by Dr. Das and Dr. Banani Bhattacharya. According to the report, the stucco sample contained angular rock particle of lime stone mainly dolomite and small quantity of charcoal and brick bats. In this compound, the most significant element is the presence of low graded marble. Now the question arises that what was the source of marble stones and from where were they collected by the ancient people. In this alluvial region there is no source of stone. So, people quarried it from the neighbouring Chotonagpur plateau regions (Sengupta.2012) where stone was easily available. Now the presence of marble stone in the stucco compound in this region raises some important issues regarding stone quarry, mobility, and trade connections. So, the scientific analysis of this material not only gives us its composition but it brought to light several other factors related to the ancient settlement, people and socio-economic conditions. In eastern India stucco became an integral element of Buddhist monasteries. So, its deliberate application over wall surface for plastering, cementing the brick structures and coating to the water prone areas such as drain, are visible which was a very common factor in the structural activities.
