Sacred Ensembles of Hoysalas

Heritage: Journal of Multidisciplinary Studies in Archaeology 10 (2022-23): 82-109

Abstract: *The Sacred Ensembles of Hoysalas, comprising the Kesava Temple (Belur), Hoysalesvara Temple (Halebidu), and Kesava Temple (Somnathpura), represent the architectural and cultural legacy of the Hoysala dynasty in Karnataka. These temples, recognized for their intricate craftsmanship and historical significance, have been under systematic conservation since the early 20th century. Initially protected by the Mysore government and later by the Archaeological Survey of India (ASI) post-1951, conservation efforts have included structural stabilization, chemical cleaning, and sculptural restoration. Excavations at Halebidu have revealed remnants of earlier structures, indicating a continuous sacred landscape. Conservation measures such as reinforcement of beams, removal of accretions, and weatherproofing have addressed both structural and environmental challenges. The study highlights pre- and post-independence restoration, emphasizing financial allocations, engineering challenges, and documentation efforts recorded in Mysore Archaeological Reports and Indian Archaeo

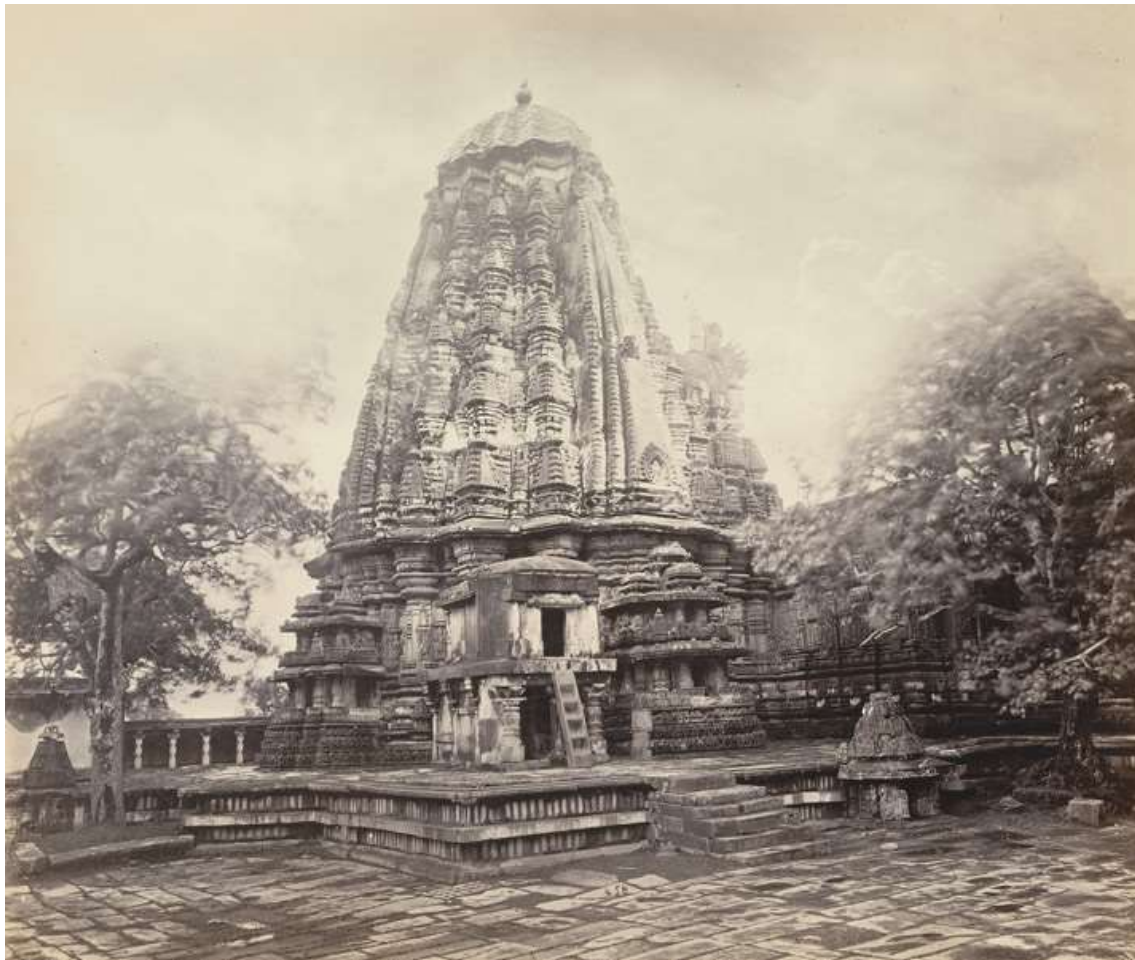
Figure 1: View of Channakeshava Temple with a bhumija shikhara (1868)
(Image Source: British Library Archives)

Keshava temple (Figures 1 and 2) is one of the ornate varieties of Hoysala art and architecture built in 1117 CE by the Hoysala king Vishnuvardhana. According to the inscription, this temple is known as Vijaynarayana. In east-west orientation over a jagati, the shrine on plan has a garbhagriha, an antarala or sukanasi, a mahamandapa and mukhamandapa in north, east and south. The plan in the region of sanctum is stellate (Figures 3 and 4) and is of indented square in the region of mahamandapa and mukhamandapas. At the eastern entrance, the royal emblem flanking the doorway on either side is a unique feature for this temple wherein the other Hoysala monuments have the royal emblem over sukanasi. Of all the three mukhamandapas, only the eastern one has perforated screens and sculptured panels of royal personalities, a later addition in the time of Narsimha. The adhishtana mouldings have friezes of elephants, lions, horse riders, kirtimukha scrolls and support the Chaturvimsati forms of Vishnu, Siva as Gajasuramardana, Vamana and Bali, Narasimha slaying Hiranyakashipu, Arjuna aiming at matsya-yantra, Rati and Manmatha. The sanctum has the two-storeyed devakoshthas with images of Narayana, Vasudeva and Madhava. The three entrances have highly ornate door frames with elaborately sculptured makara torana with Narasimha slaying Hiranya kashipu, Varaha slaying Hiranyaksha and Lakshmi Narayana with respective retinues. The temple is known for its exuberantly sculptured thirty-eight bracket figures placed over pillars between eave and capital of each pillar in the region of mukhamandapa and mahamandapa depicts female sculptures known as Madanikas. There are also a few other subsidiary structures and shrines.

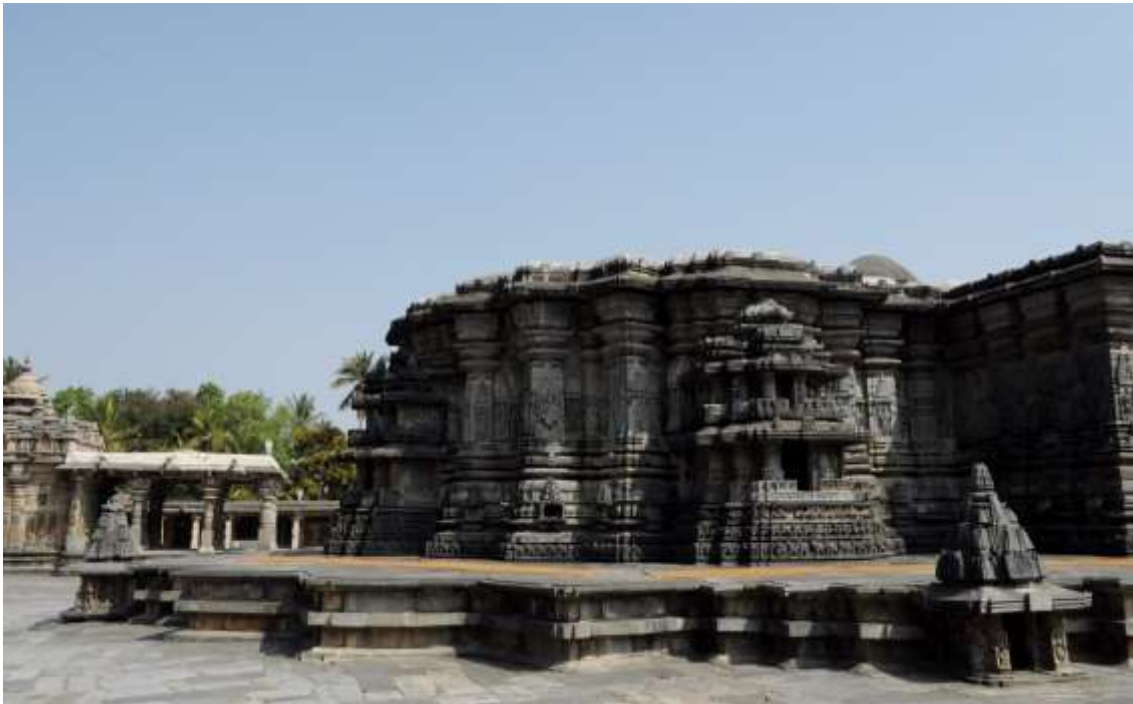
Figure 2: View of Channakeshava Temple without the Shikara (2020)
(Image Source: ASI)

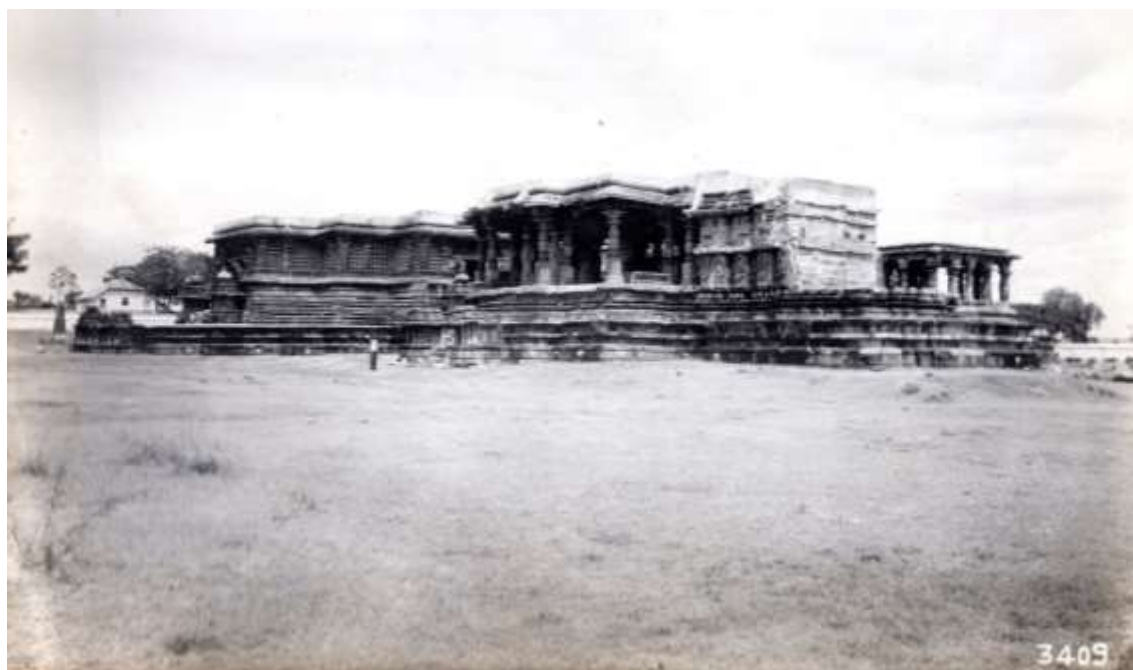
Figure 7: General view of Hoysaleswara Temple, Halebidu (1868)
(Image Source: British Library Archives)

Hoysaleswara Temple, Halebidu: The Hoysaleswara temple (Figure 7 and 8), called as 'Vishnuvardhana Poysaleswara', in inscription in honour of the Hoysala king Vishnuvardhana was built in 1121 CE. It is an ornate dvikuta shrine of twin Siva temple in east-west orientation caused by Ketamalla Dandanayaka. Later epigraphical

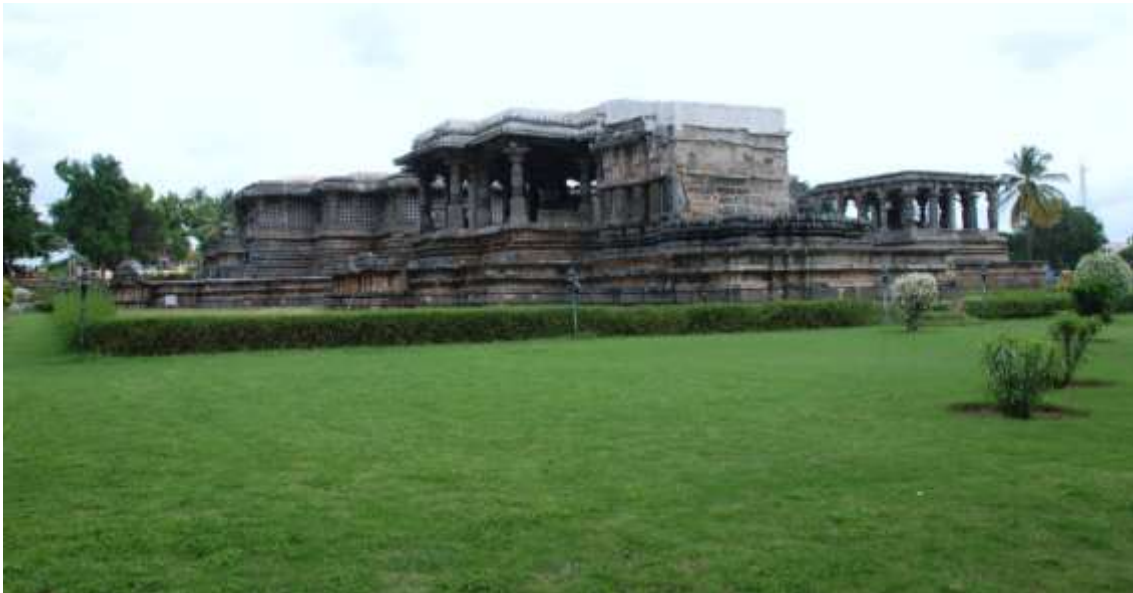
Figure 8: General view of Hoysaleswara Temple, Halebidu (1968) (Image Source: ASI)

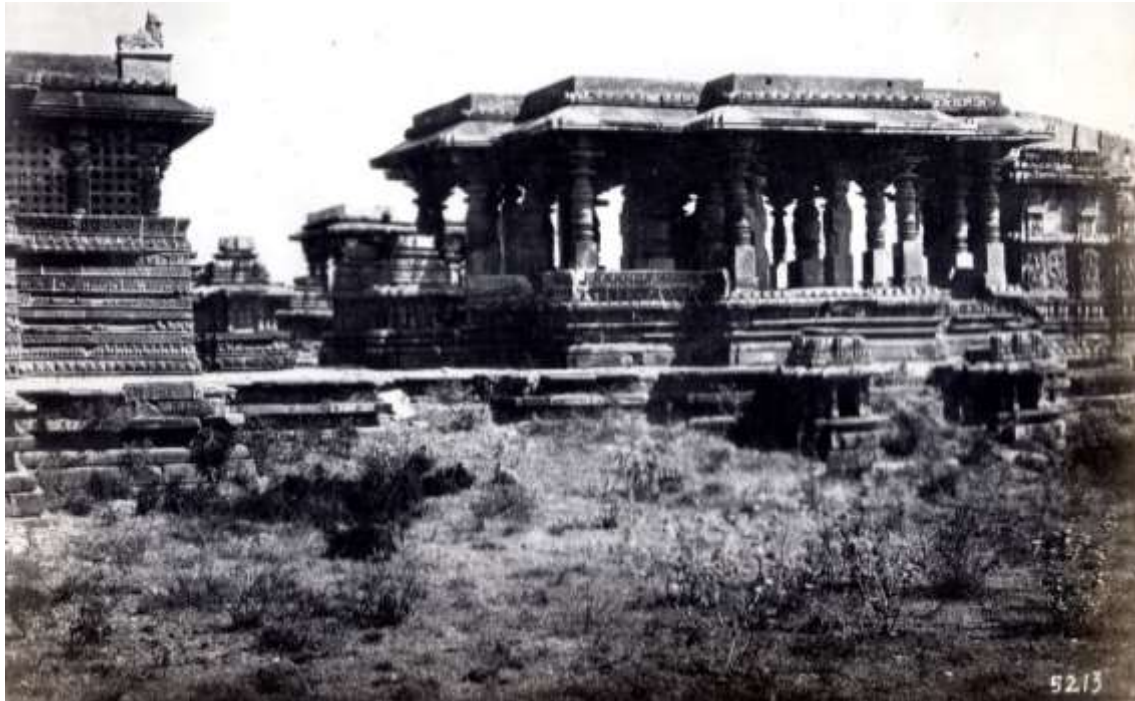
Figure 9: View of Hoysaleswara Temple, Halebidu (1868)
(Image Source: British Library Archives)

records hail it as 'Hoysaleswara panchikeswara'. On plan, it has a sanctum, a vestibule, a hall and porch which are fused together in the region of hall of dance. Slightly away from the respective eastern mukhamandapas are two nandi mandapas (Figure9 and 10) built over the same jagati. There are four entrances to the twin temple which are typical to the style flanked by miniature shrines. Even the nandi mandapa also has such shrines giving a grand elevation to the temple proper. The jagati offering an imposing elevation to the monument has a flight of steps towards the north and south leading to respective shrines in addition to a flight of steps on the southern side of southern nandimandapa. To the east and west were added two shrines known as Shantaleshvara (west) and Ballaleshvara (east) according to inscriptions and the shrine of Surya was built abutting the southern nandimandapa. The temple once had a prakara with an imposing gateway on the south with royal emblem placed over these mandapas. This temple marks the culmination of Hoysala sculptural art and architecture wherein more than four hundred wall sculptures of exquisite workmanship belonging to Saiva and Vaishnava pantheons, adorn the walls, mixed with secular themes placed over the sculptured adhishtana which has in all 11 friezes of animals, scrolls, swan and makara, etc The bhitti sculptures of dancing Ganesa, the trinities, seated Sarasvati, Govardhanagirdhari, Siva as Gajasuramardana, dancing Sarasvati, dancing Bhairavi, Mahishamardini are some of the masterpieces of Hoysala art in this temple.

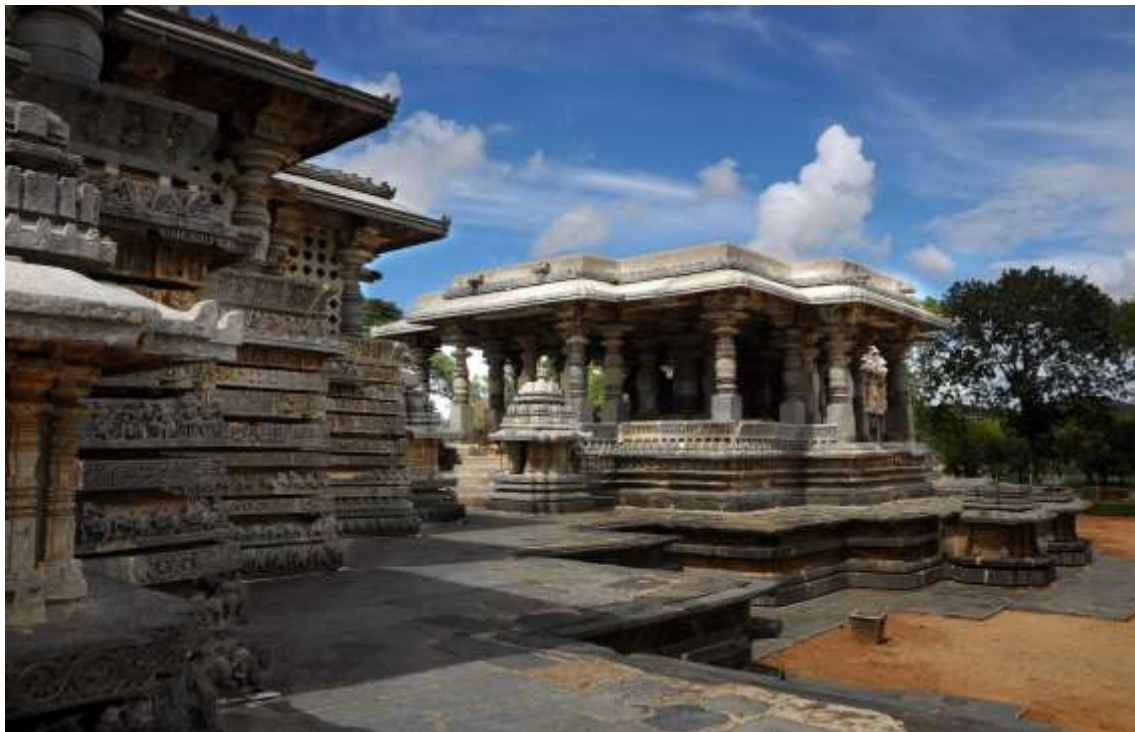
Figure 10: View of Hoysaleswara Temple, Halebidu (2020) (Image Source: ASI)
